SUMMARY SHEETS

Condition of structures

Background. Port Grimaud was built in the 1960s and 1970s, and after almost 50 years in operation, an inspection of the structures is now due. The port is currently experiencing a number of technical problems linked to natural ageing, exacerbated by a lack of maintenance and a lack of infrastructure development.

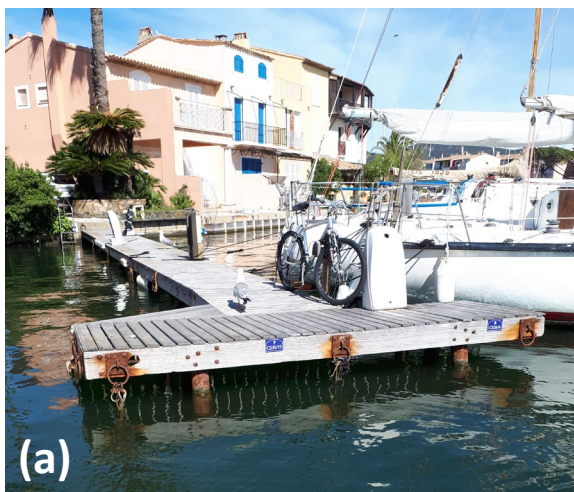
- (a) Ile du Couchant pontoon: traces of corrosion on the piles and mooring rings.
- (b) Shipyard landing stage: spalling, exposed metal reinforcement and cracks.
- (c) Church landing stage: temporary repairs in 2022 (floats, anchors); overall repairs required (emergency work).

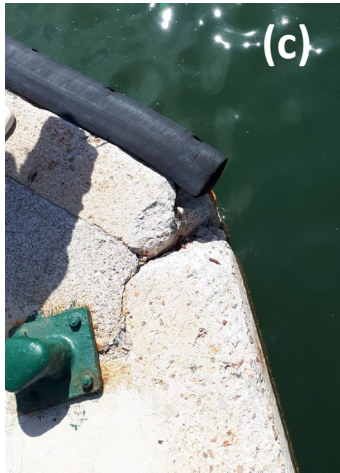
(c) Fuelling station quay: spalling, corrosion, cracks.

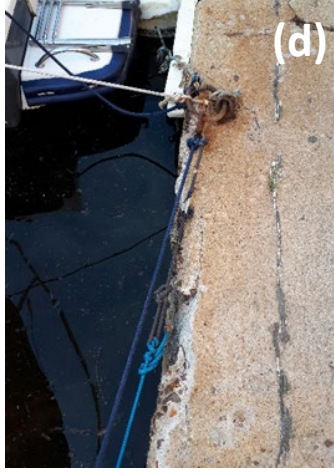
(d) Quai des Fossés Est: cracking, spalling, visible metal reinforcement, limited accessibility.

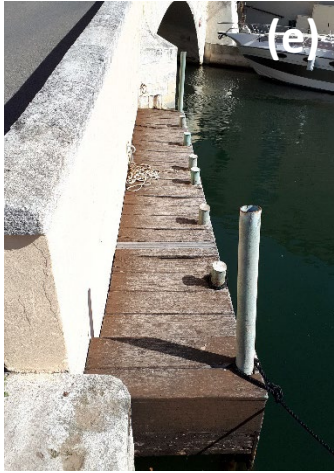
(e) Quick stop landing stage: limited accessibility, damaged decking.

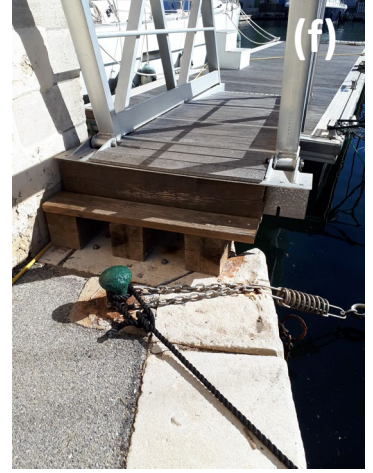
(f) Church square footbridge: dangerous access.

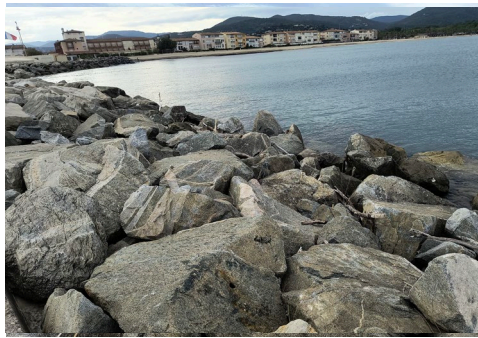
(g) Outer harbour breakwater: loose riprap structure.

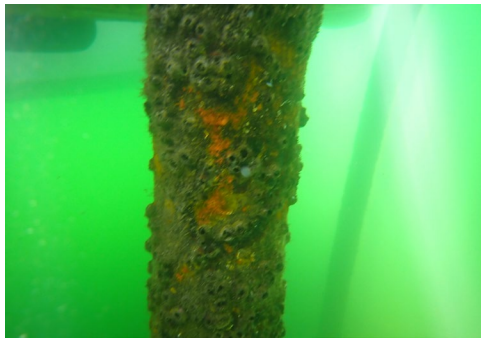
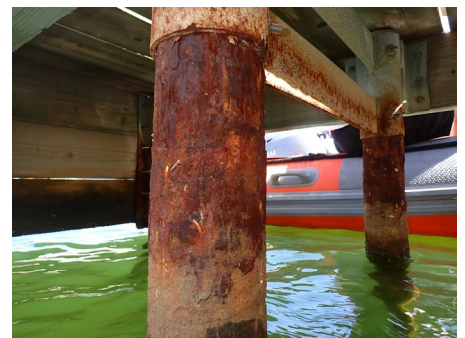
(h and i) Pontoon 15 - PG1: corroded piles.
